**Yorktown Elementary School (YTES)**

**UPPER PATUXENT RIVER WATERSHED RESTORATION ACTION STRATEGY (WRAS)  
FORM 1 -- Catchment Information**

Site Name: Yorktown Elementary School Address: 13463 Yorktown Drive, Bowie MD, 20715  
 Site Owner: Board of Education  
 State Plane Coordinates of Site Centroid: X: 1388257 Y: 481968 Date: 4/2/03  
 Personnel: PM Weather: sunny, 75F deg  
 Area (ac): 9.5 Impervious Area (ac): 2.7  
 Percent Impervious: 28% Soil Recharge Factor (S): 0.37  
 WQ<sub>v</sub> (required): 0.24 Re<sub>v</sub> (required): 0.09  
 Property Area (ac): 10.1 Property Area Included in Site: 95 %  
 Amount of Catchment Occupied by Site: 91 %

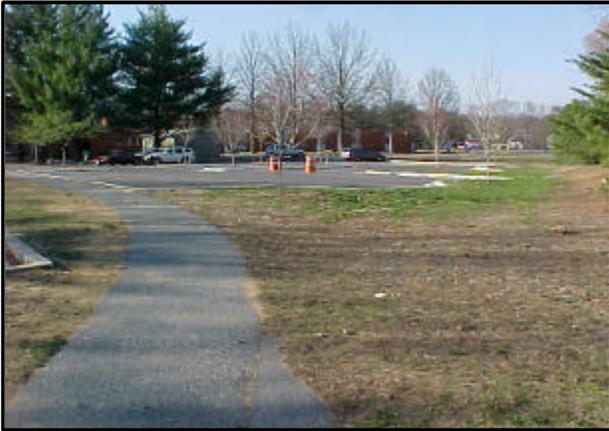
- No. 515 Description: looking north across new parking lot
- No. 516 Description: looking northwest across old parking lot
- No. 517 Description: looking east at front (southwest) side of building
- No. 518 Description: looking southeast at front (southwest) side of building
- No. 519 Description: looking southwest at northern portion of school
- No. 520 Description: looking south at northern portion of school
- No. 521 Description: looking southeast along northeast side of building
- No. 522 Description: looking southwest along southeast side of building
- No. 523 Description: looking south across parking lot
- No. \_\_\_\_\_ Description: \_\_\_\_\_
